Manhole Inspection Summary

Manhole # S15U__013MH

Insp Date: **6/25/08 2:25 PM**

Location Address: **2717 wilmarco av**

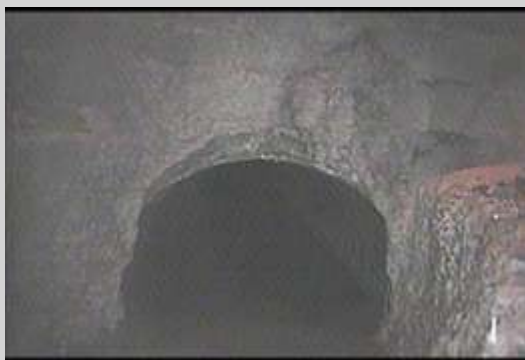
6 O'Clock Inflow

12 in. Circular Gravity Sewer
Pipe In @ 6 O'Clock

Pipe Height: **12** (in.) Rod and Bar (Angled)
Pipe Material: **Clay** ☐ Pipe Lined
Invert Depth: **19.41** (ft.) Flow Characteristics: **Slow**
Deposits: ☒ None ☐ Mud ☐ Sludge ☐ Debris ☐ Grease
Silt Depth: **0** (in.) Deposits Extent:
Infiltration: **None** Pipe Seal Cond: **Unknown**
